FEASIBILITY OF USING RECON III-B AS A COAST GUARD
HAZARDOUS CHEMICAL SPILL... (U) PERRY OCEANOGRAPHICS INC
RIVIERA BEACH FL G S MANERS ET AL. SEP 82 USCG-D-6-83
DTCG39-81-C-80311

FINAL REPORT

1. Report No. CG-D-6-83	2. Government Accession No. HD A127309	3. Recipient's Catalog No.	
4. Title and Subtitle "Feasibility of Using RECON III-B as a Coast Guard Hazardous Chemical Spill Response Tool"		5. Report Date September 1982

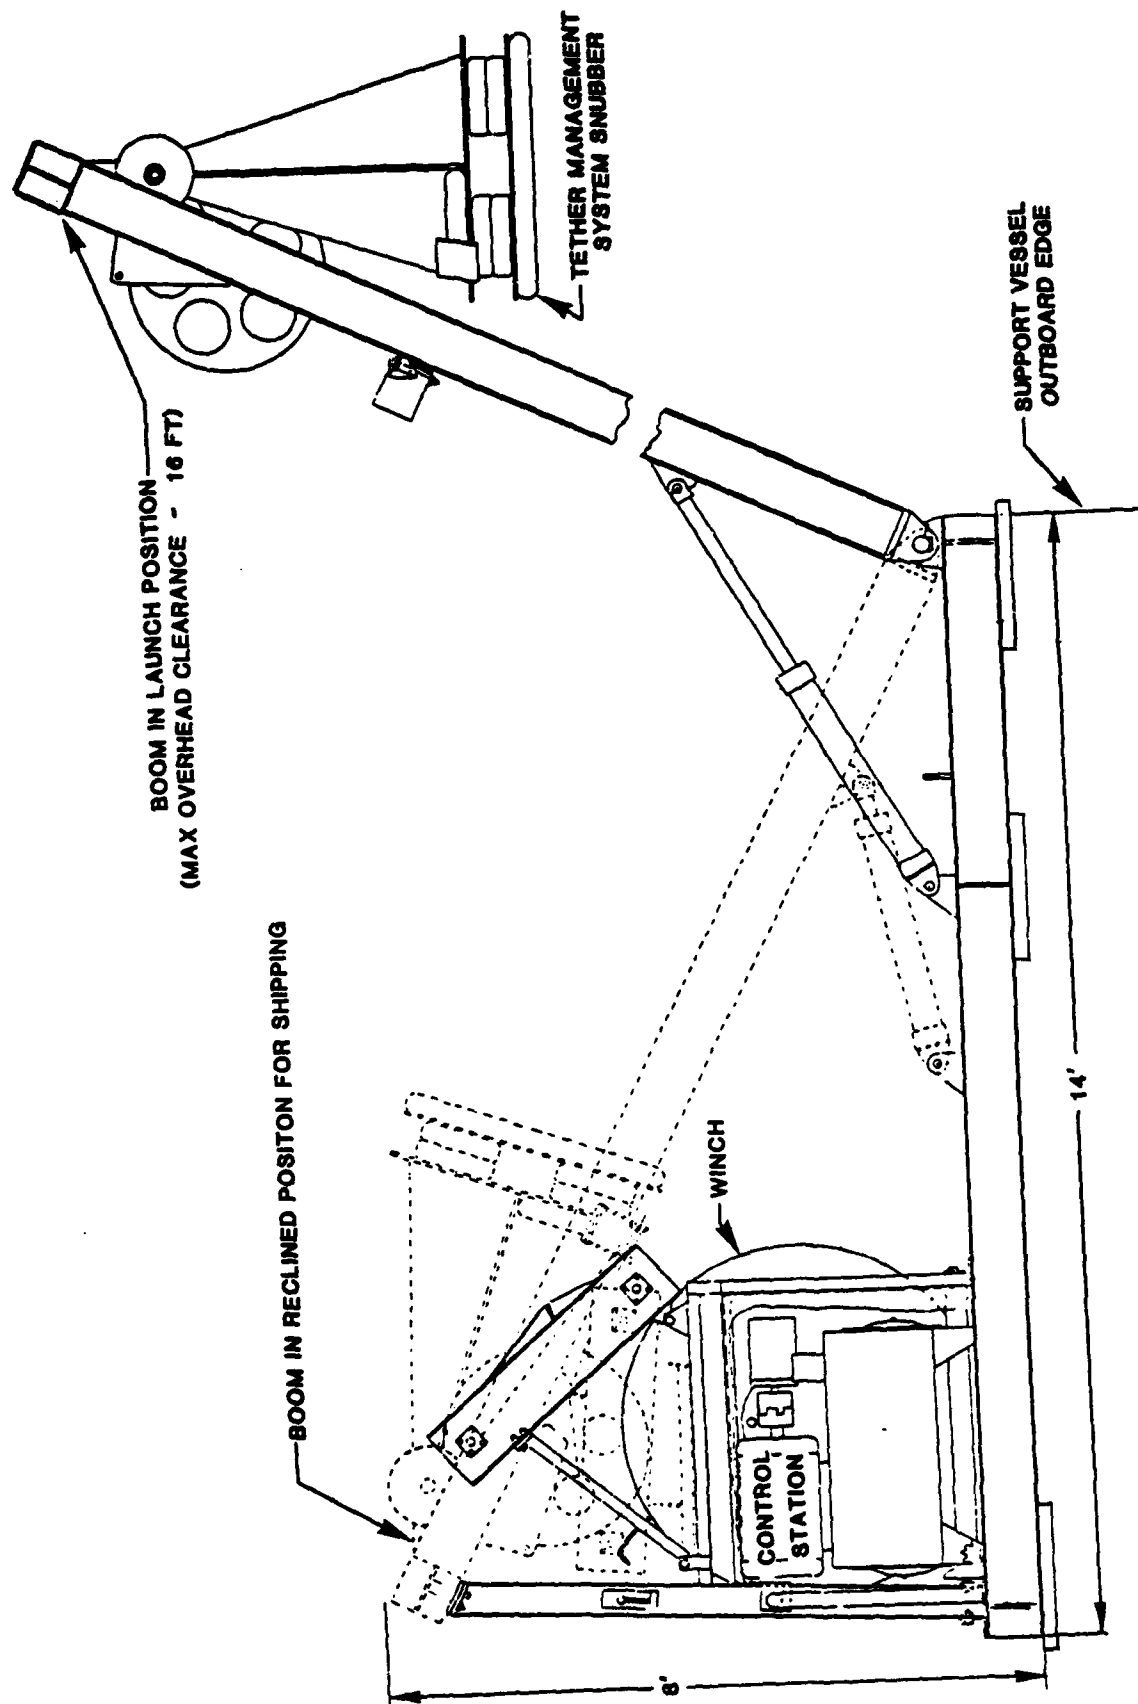
Figure 2-2 RECON III-B HANDLING SYSTEM (SIDE VIEW)

The RECON III-B system consists of 3 major components; the deployment module, including the operating vehicle and tether management system, Figure 2-1, the handling system which includes the winch and boom, Figures 2-2 and 2-3, the control module consisting of the main vehicle console, Figure 2-4, and the auxiliary console, Figure 2-5.

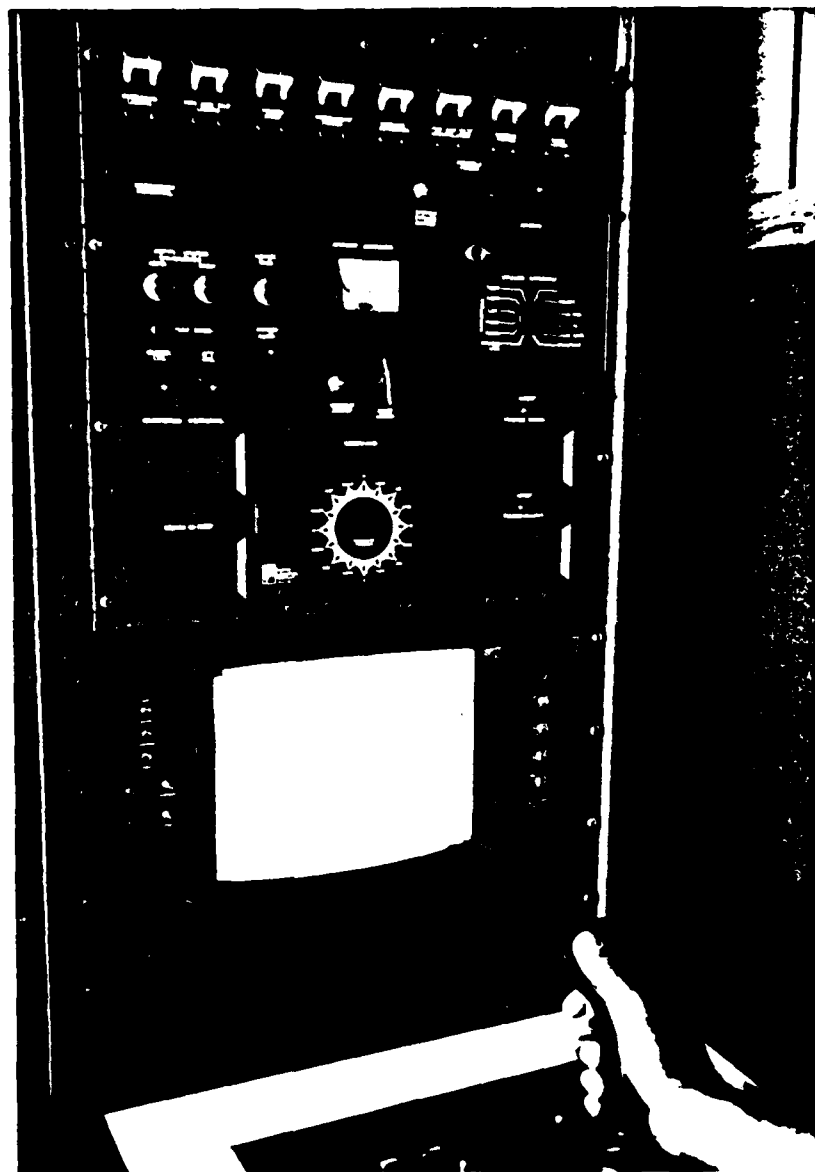
FIGURE 2-4. Main Vehicle Console

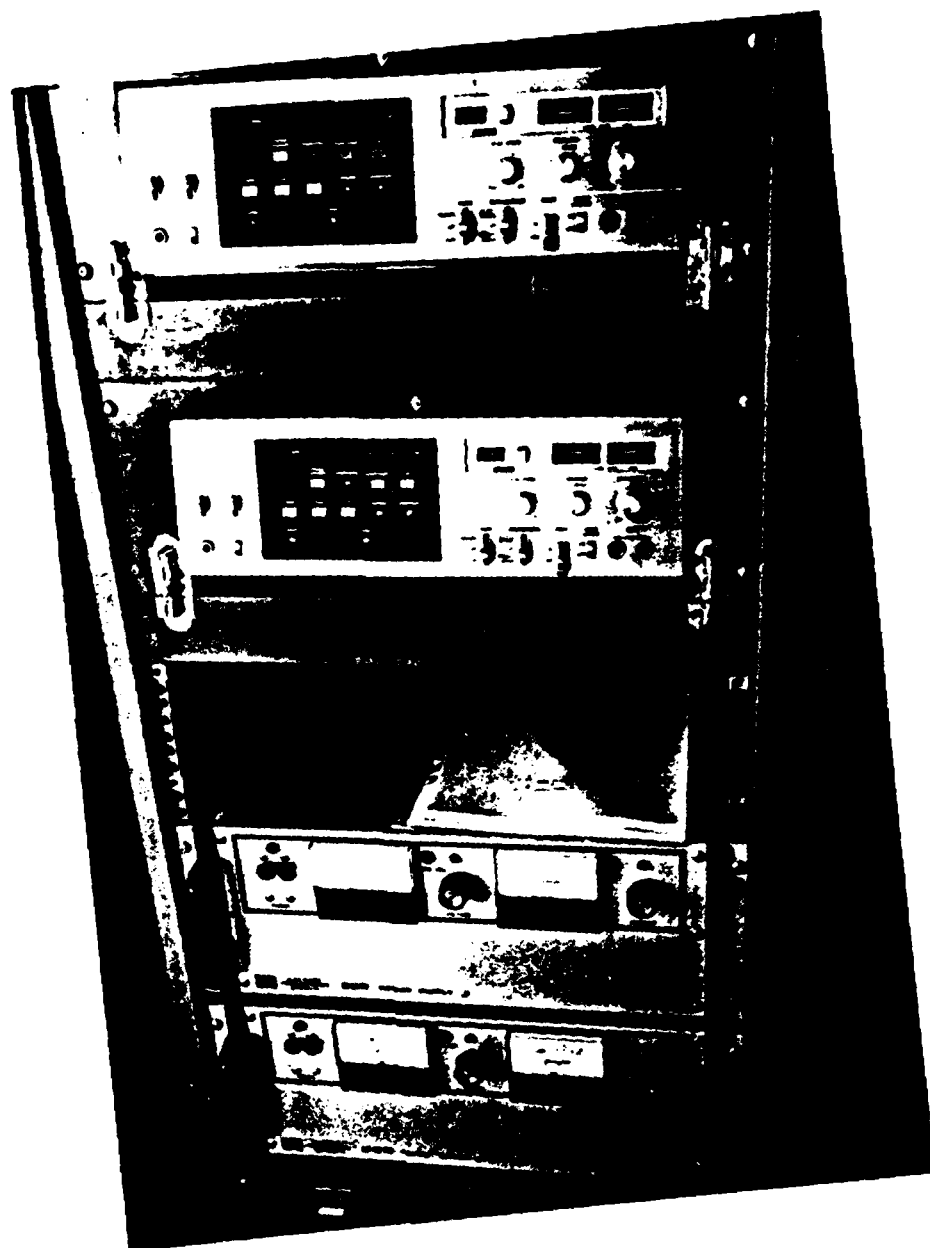
FIGURE 2-5. Auxiliary Console
